# Parts Catalog - Option Detail

Electronic Parts Catalog - Option Detail				
Option	Group	Graphic	Film Card	Date
BR9039-05	03.02	br941ga	Z	18-JUL-00
<b>Engines</b>	6C8.3, C GAS PLUS CM556, G8.3, G8.3 CM558, GTA8.3 CM558, ISC CM2150, ISC CM554, ISC CM850, ISC8.3 CM2250, ISC8.3 G CM2180 C101, ISL CM2150, ISL CM554, ISL CM850, ISL G CM2180, ISL8.9 CM2150 L110, ISL8.9 CM2880 L112, ISL9 CM2150 SN, ISL9 CM2250, ISL9 CM2350 L101, ISL9 CM2350 L111, ISLE4 CM850, L GAS PLUS CM556, L8.9, L8.9 L121, L8.9G CMOH2.0 L125B, L9 CM2350 L116B, L9 CM2350 L119B, L9 CM2350 L120C, L9 CM2350 L123B, L9.3 L105, L9.5 L117, L9N CM2380 L124B, QSC8.3 CM2250, QSC8.3 CM2880 C102, QSC8.3 CM554, QSC8.3 CM850(CM2850), QSL9 CM2250, QSL9 CM2250 L115, QSL9 CM2350 L102, QSL9 CM2350 L107, QSL9 CM2350 L118, QSL9 CM2350 L122, QSL9 CM554, QSL9 CM850(CM2850), QSL9 G CM558, QSL9 M CM2250 L106, QSL9.3 CM2880 L113

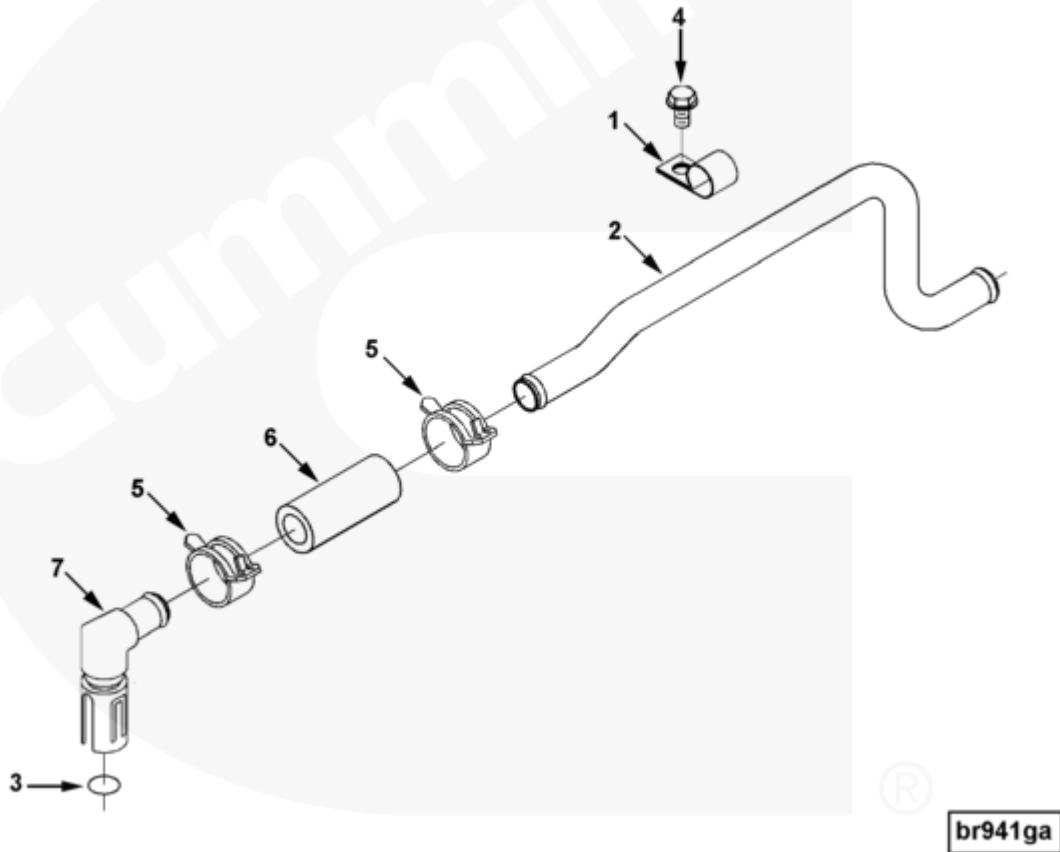
Cart	Ref No	Part Number	Part Description	Required	Remarks
<a href="#">View My Cart</a>					
		BR9039-05	Crankcase Breather		<a href="#">MR - BREATHER, CRANKCASE...(More)</a>

Breather Type: Open
					Breather Vent Tube End
					Location: Rear of Engine
					Breather Vent Location:
					Between 3 & 4
					Unique Characteristics:
					Parallel to Crank Centerline
					Rearward
					Engine Family: C Series
					Engine Aspiration:
					Turbocharged; Sea Water
					Aftercooled
					A Compatible Air Cleaner
					System Designed for Closed
					Crankcase Ventilation is
					Required for a Complete
					Closed Crankcase Ventilation
					System
<input type="checkbox"/>	1	<a href="#">202888</a>	Clip	2	
<input type="checkbox"/>	2	<a href="#">3866727</a>	Breather Tube	1	
<input type="checkbox"/>	3	<a href="#">3936331</a>	Rectangular Ring Seal	1	
<input type="checkbox"/>	4	<a href="#">3912072</a>	Self Tapping Metal Screw	2	M8 x 1.25 x 15
<input type="checkbox"/>	5	<a href="#">3937613</a>	Hose Clamp	2	
<input type="checkbox"/>	6	<a href="#">3918611</a>	Plain Hose	1	
<input type="checkbox"/>	7	<a href="#">3935113</a>	Vent Connection	1	Service With 3934865 Seal
